**failures of self-monitoring and reporting of mercury
at the De Beers Victor diamond mine in Canada**

December 2015

SPECIAL REPORT

CPAWS Wildlands League

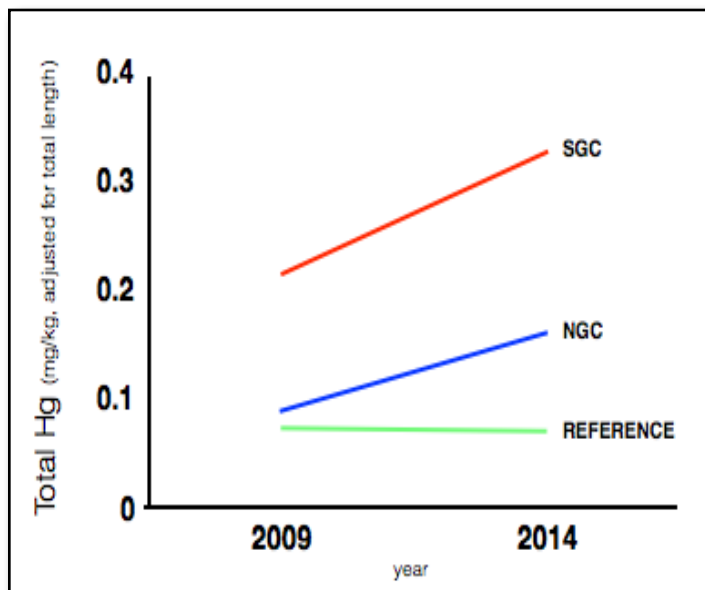
[Figure 8] Simplified illustration of reported differences between the 2009 and 2014 Pearl Dace (minnow) average body burdens (corrected for length-year). Adapted from Fig. 9 of De Beers' 2014 annual Mercury Performance Report.
